Council Meeting Agenda
7995 N Century Blvd.
June 06, 2023
7:00 p.m.

HAZARDOUS MATERIALS SURVEY REPORT

CENTURY AND CARVER COMMUNITY CENTERS Century, Escambia County, Florida

Visual Structural Assessment for Carver Community Center
Project No.: Q0118.01-601
Issued Date: May 16, 2023

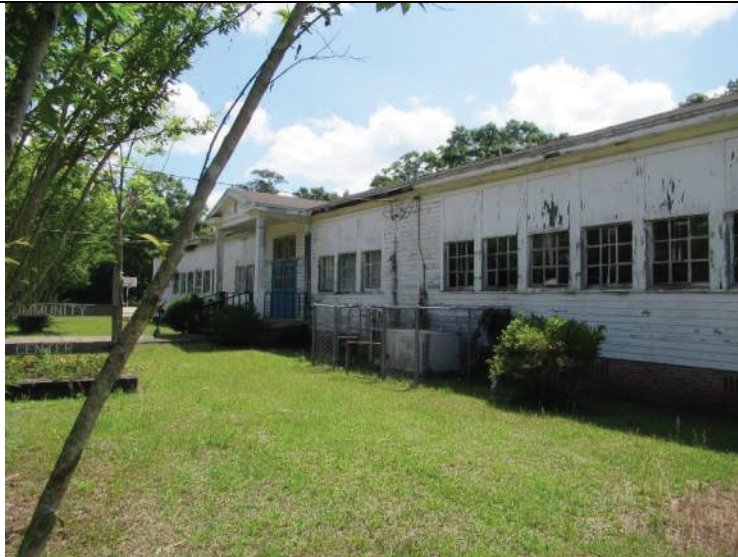
Photograph No. 1.

Front northwest corner of the building. Extensive wear and tear observed from Jefferson Avenue.

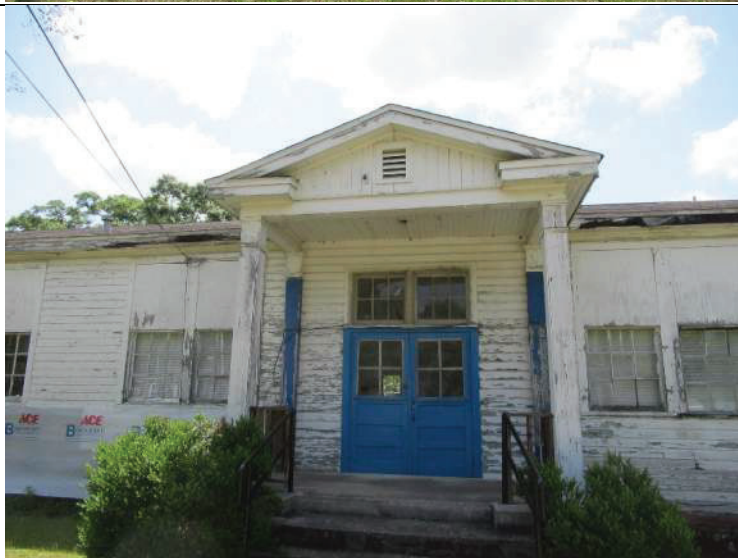
Photograph No. 2.

Front entry canopy located on the north side of the building. Damaged fascia, siding, windows, porch post, and entry doors easily observed from walkway to the steps.

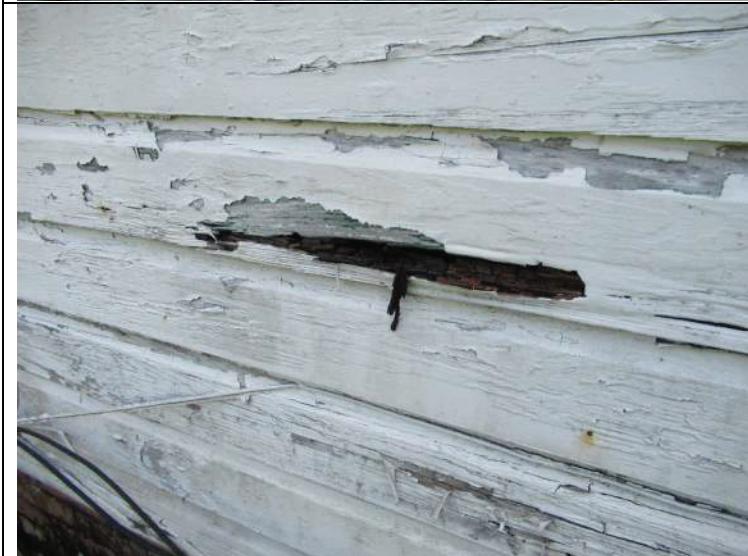
Photograph No. 6.

Typical Novelty siding in disrepair. Wood rot was found throughout the building. The white paint was peeling off of most of the building. We understand all painted surfaces have lead in the matrix.

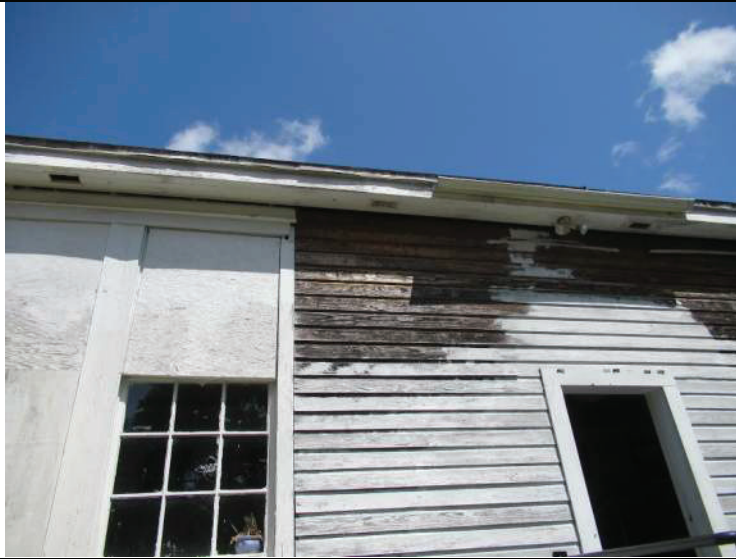
Photograph No. 7.

South elevation where an entry door was installed. The newer Novelty siding was in distress, starting to rot, and will need to be replaced.

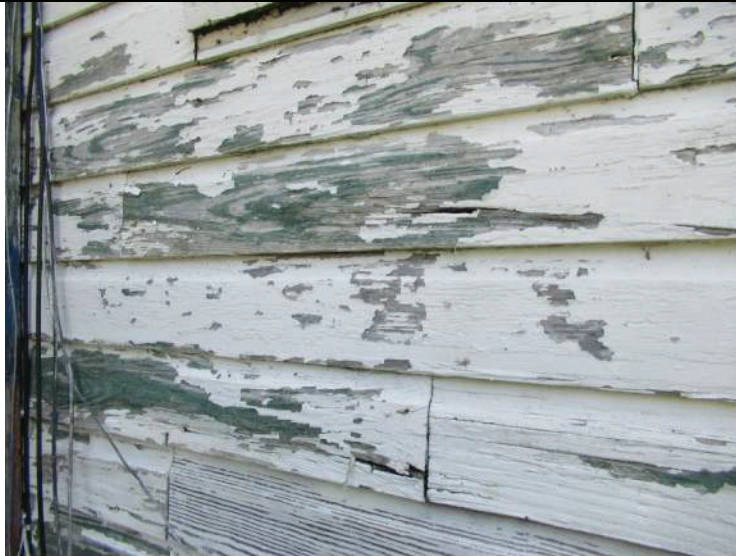
Photograph No. 8.

Original siding showing the years of wear and tear along with wood rot.

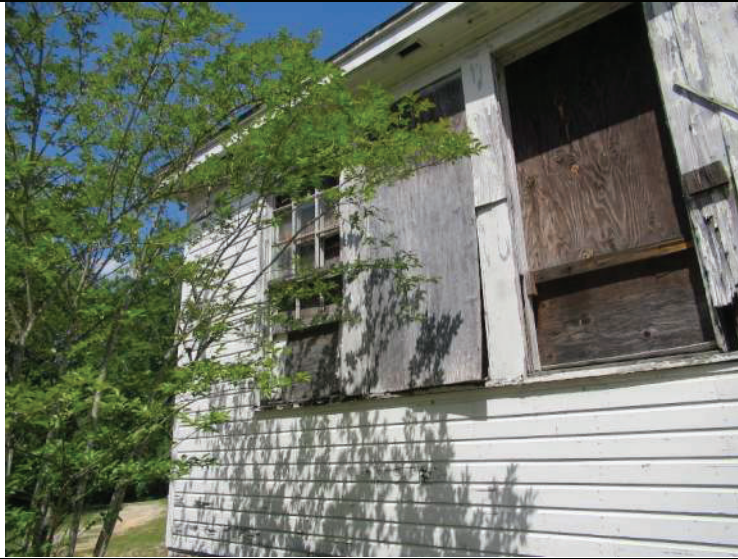
Photograph No. 9.

Windows to the southwest classroom were totally rotted out including protection boards installed over original windows. The windowsills, middle post between units, upper and lower stiles/sashes, and frames are totally rotted out with missing glazing.

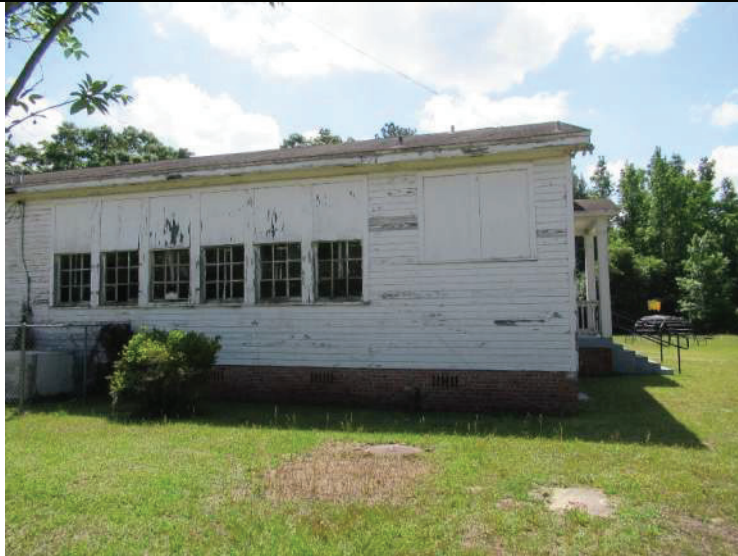
Photograph No. 10.

Windows to the northwest classroom were totally rotted out including protection boards installed over original windows. The windowsills, middle post between units, upper and lower stiles/sashes, and frames totally rotted out with missing glazing.

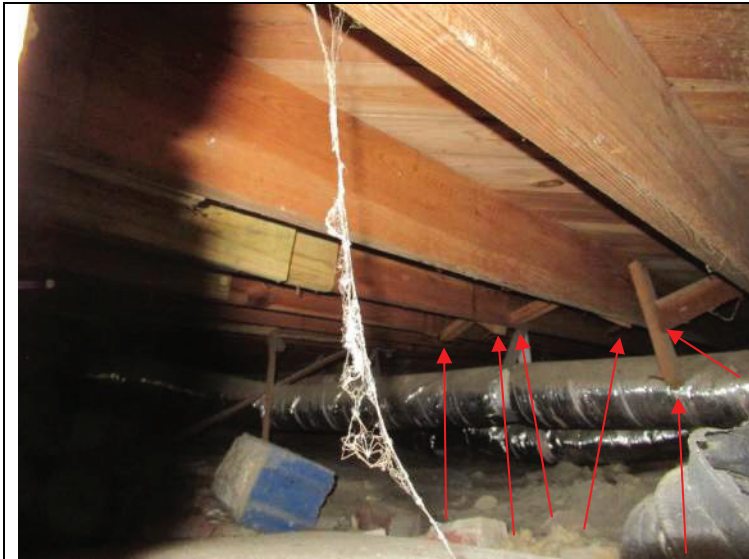
Photograph No. 27.

Mid-span "X" cross bracing broken off bottom edge of floor joist.

A risk of wall / floor structure collapse is feasible.

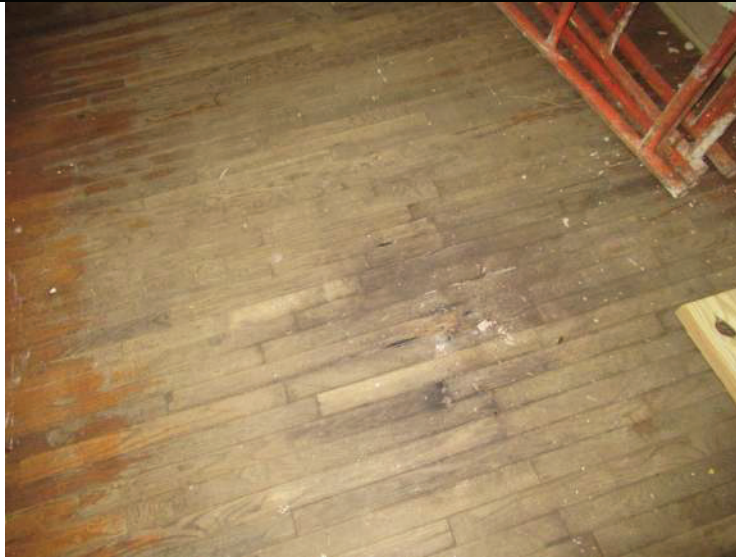
Photograph No. 31.

Typical damaged wood floor.
Both the flooring and sub-
flooring had damage. This was
throughout the building.

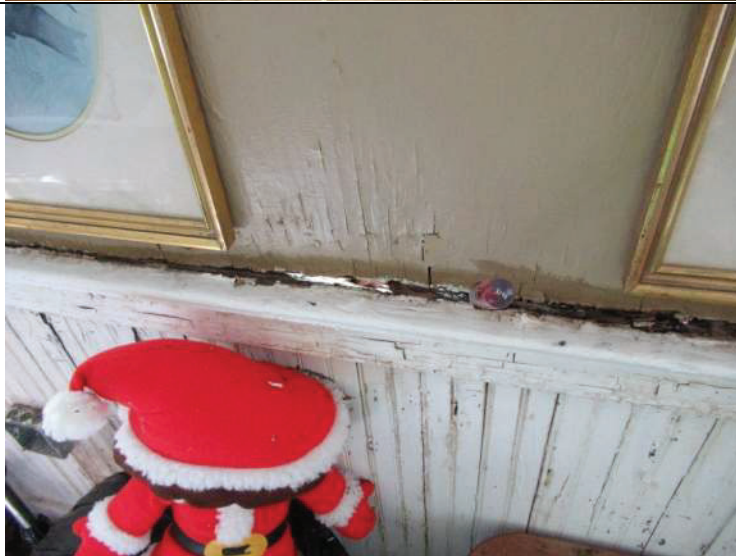
Photograph No. 32.

Typical damaged wood wall
interior surfaces.

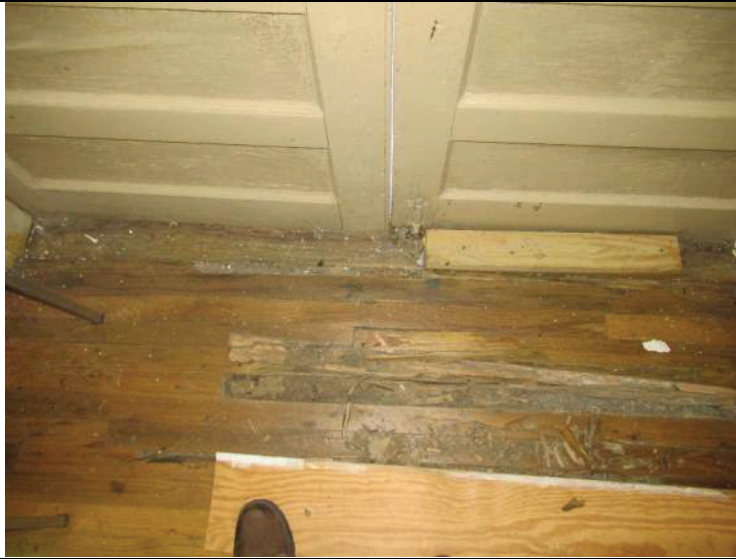
Photograph No. 33.

West entry door had significant floor damage and was found structurally unsound.

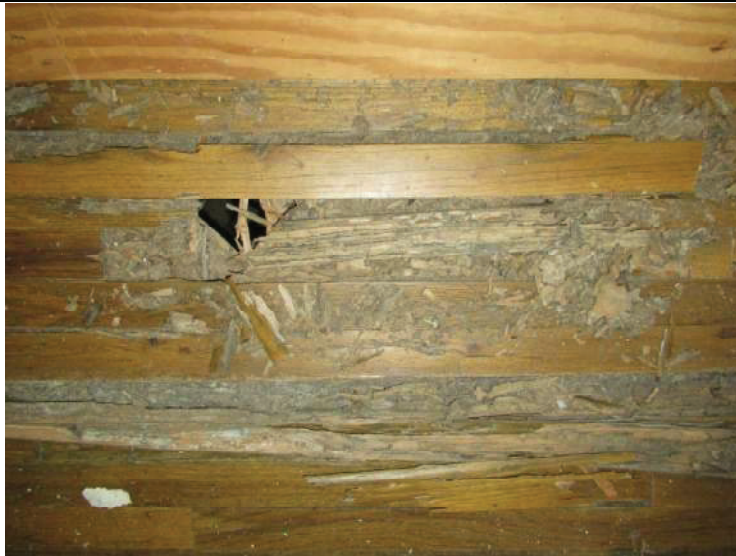
Photograph No. 34.

Temporary loose laid plywood removed from the above picture showing gaping hole in floor assembly.
