Council Meeting Minutes
Town Hall
May 16, 2023
7:00 p.m.

HAZARDOUS MATERIALS SURVEY REPORT

CENTURY AND CARVER COMMUNITY CENTERS Century, Escambia County, Florida

Visual Structural Assessment for Carver Community Center
Project No.: Q0118.01-601
Issued Date: May 16, 2023

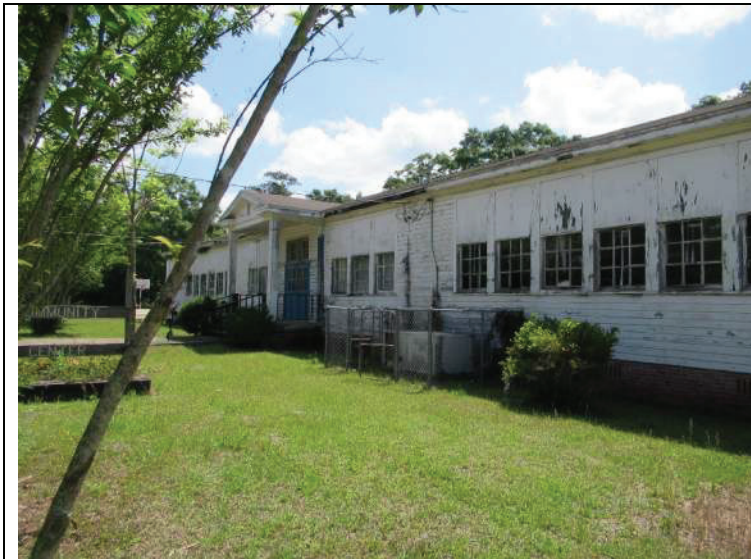
Photograph No. 1.

Front northwest corner of the building. Extensive wear and tear observed from Jefferson Avenue.

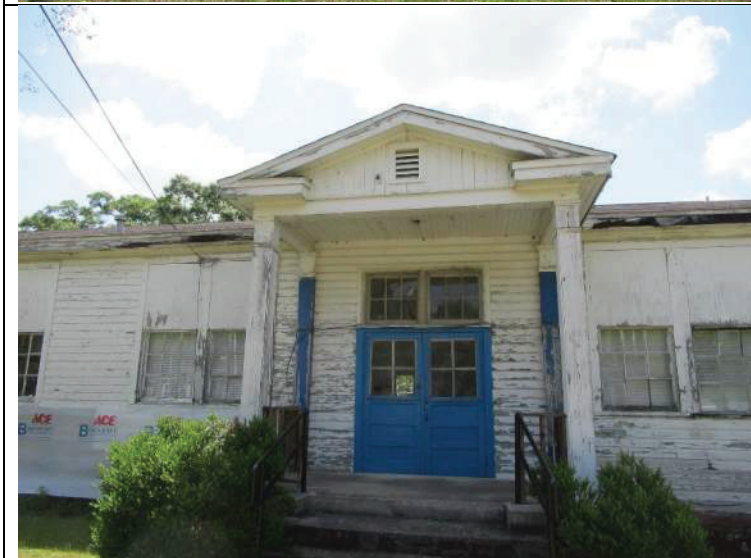
Photograph No. 2.

Front entry canopy located on the north side of the building. Damaged fascia, siding, windows, porch post, and entry doors easily observed from walkway to the steps.

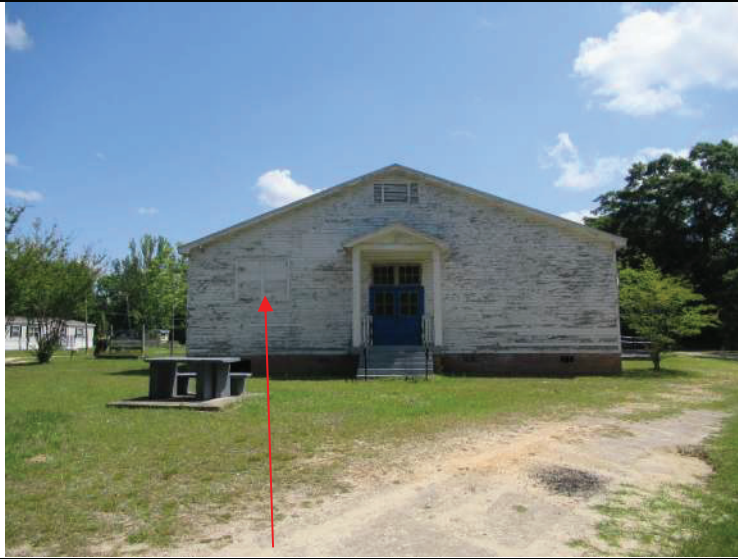
Photograph No. 3.

West end of the building shows white peeling paint and damaged "Novelty Drop" wood siding. The windows (arrow) to the girl's bathroom have been boarded up.

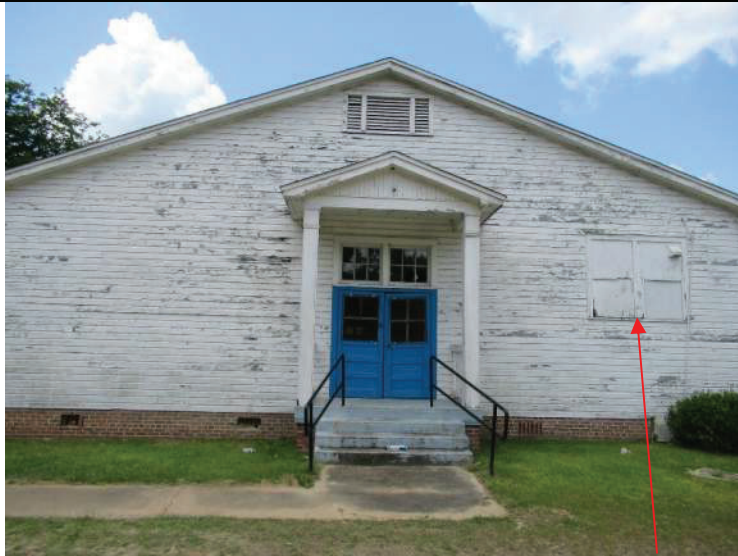
Photograph No. 4.

East end, by basketball court, has white peeling paint and damaged "Novelty Drop" wood siding. The windows (arrow) to the boy's bathroom have been boarded up.

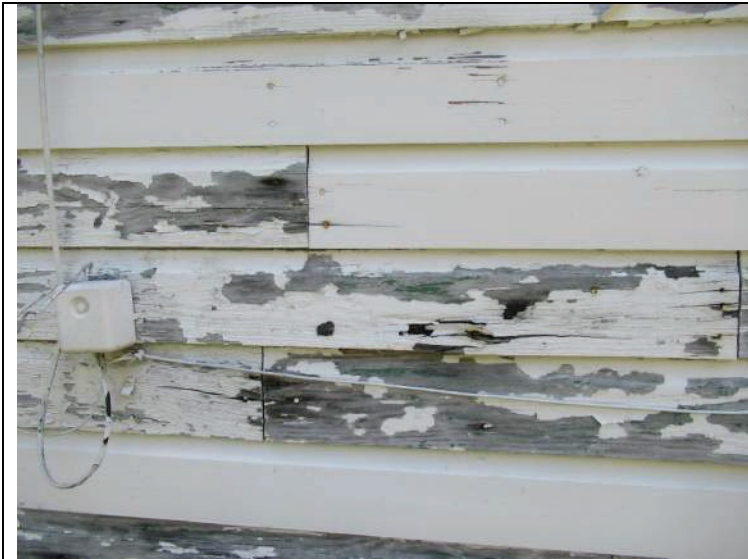
Photograph No. 5.

Typical Novelty Drop pine siding installed on exterior of building. The building was originally painted green. The white paint was peeling off of most of the building. We understand all painted surfaces have lead in the matrix.

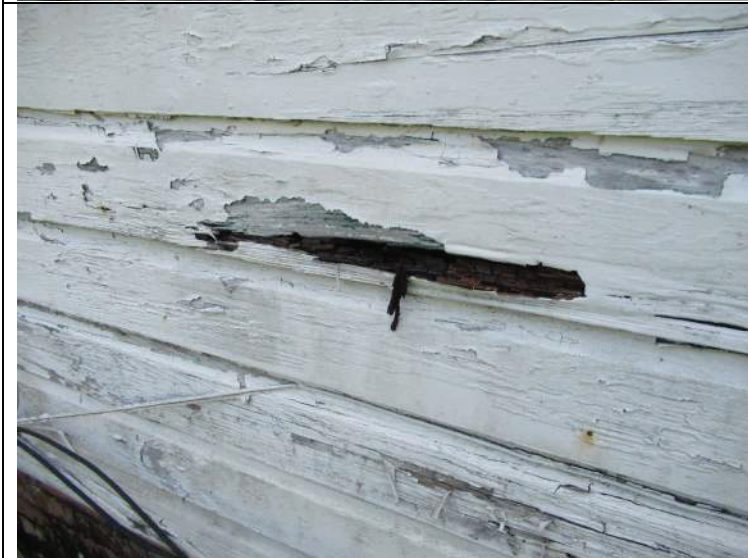
Photograph No. 6.

Typical Novelty siding in disrepair. Wood rot was found throughout the building. The white paint was peeling off of most of the building. We understand all painted surfaces have lead in the matrix.

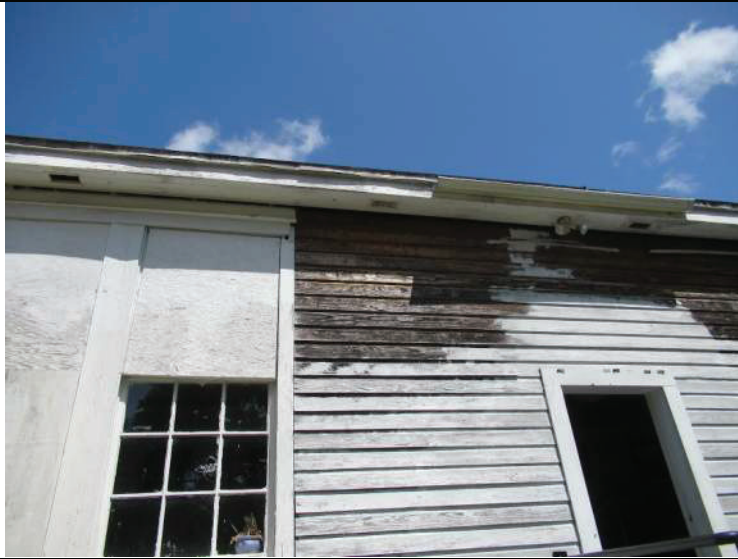
Photograph No. 7.

South elevation where an entry door was installed. The newer Novelty siding was in distress, starting to rot, and will need to be replaced.

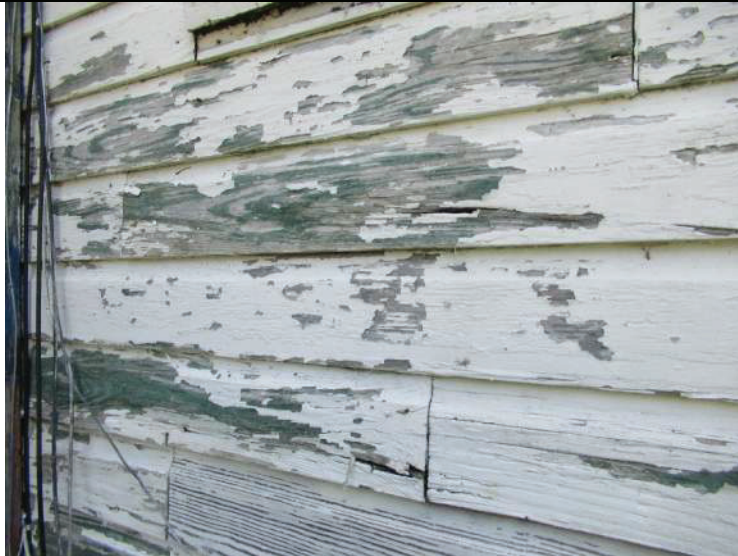
Photograph No. 8.

Original siding showing the years of wear and tear along with wood rot.

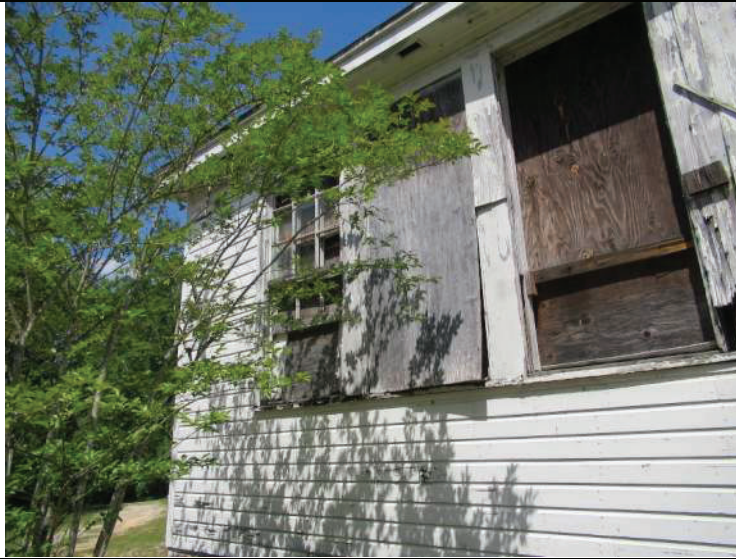
Photograph No. 9.

Windows to the southwest classroom were totally rotted out including protection boards installed over original windows. The windowsills, middle post between units, upper and lower stiles/sashes, and frames are totally rotted out with missing glazing.

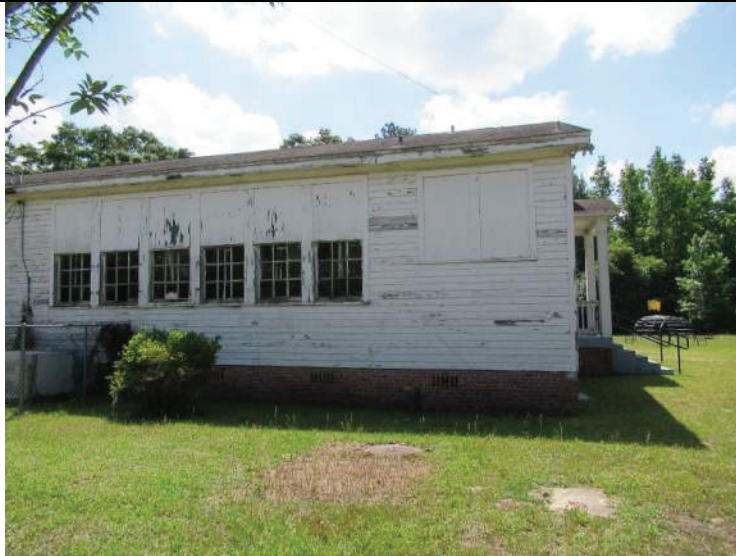
Photograph No. 10.

Windows to the northwest classroom were totally rotted out including protection boards installed over original windows. The windowsills, middle post between units, upper and lower stiles/sashes, and frames totally rotted out with missing glazing.

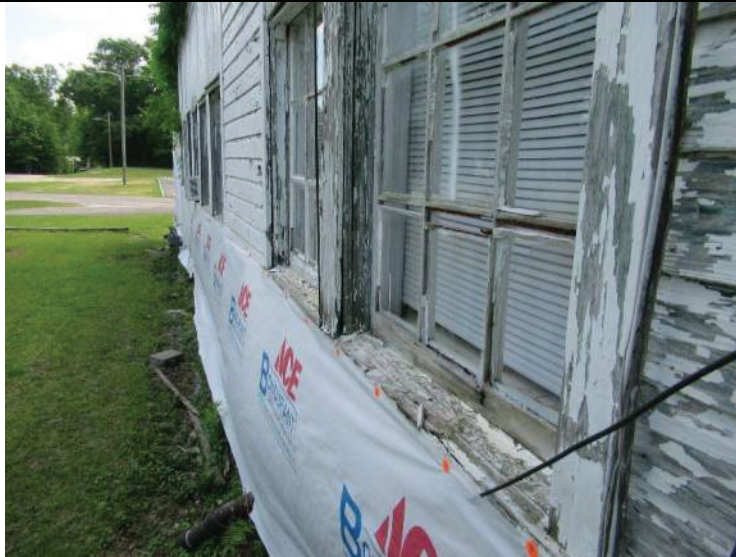
Photograph No. 11.

Windows to the northeast classroom were totally rotted out including protection boards installed over original windows. The windowsills, middle post between units, upper and lower stiles/sashes, and frames totally rotted out with missing glazing.

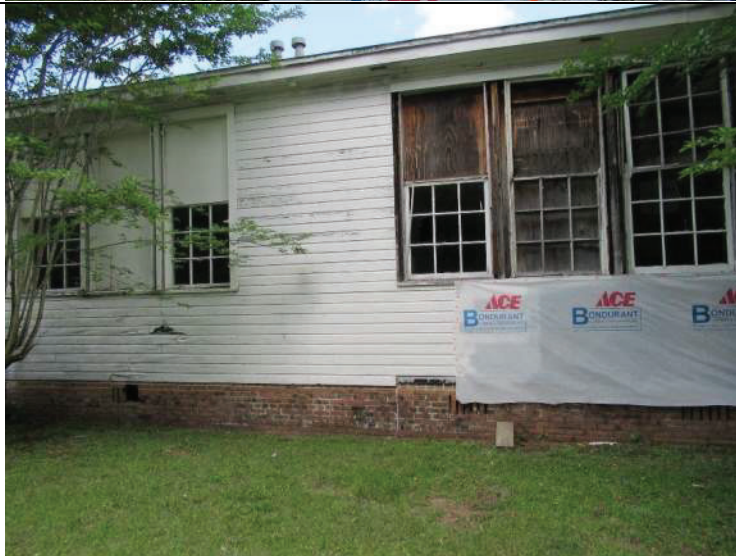
Photograph No. 12.

Windows to the southeast classroom were totally rotted out including protection boards installed over original windows. The windowsills, middle post between units, upper and lower stiles/sashes, and frames totally rotted out with missing glazing.

These windows had significant amount of window components missing.

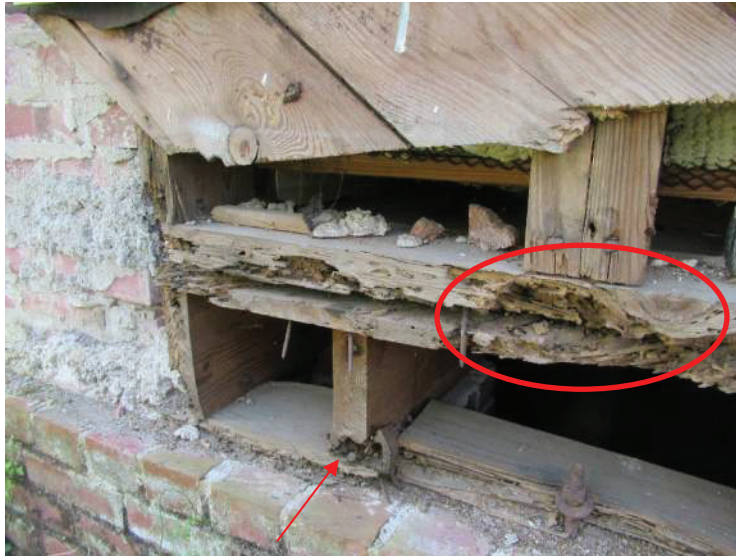
Photograph No. 15.

Bottom of wall bottom/sill plate has significant damage from both insect and microorganism eating on the wood. This component has no strength. This is consistent for over 60% of the building.

Floor joist has started to collapse due to damage from insects and/or rot. This is consistent for over 60% of the building. Interior joists bearing on wood beams and foundation piers look fair.

A risk of wall / floor structure collapse is feasible.

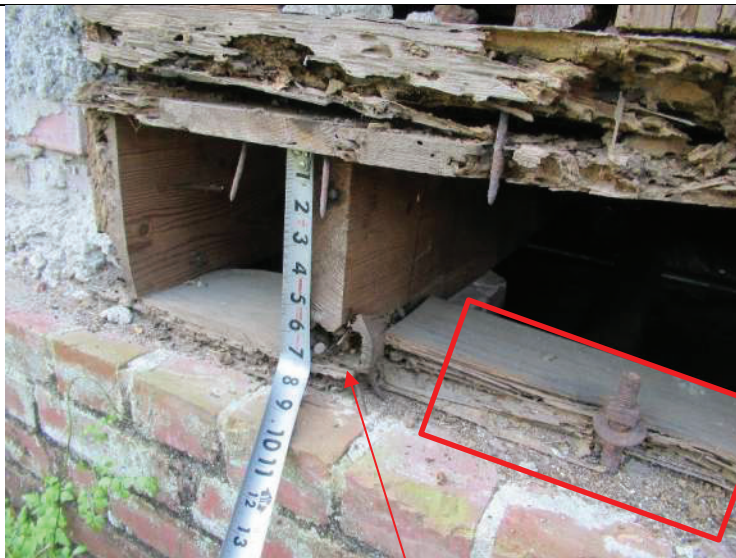
Photograph No. 16.

Closer view of damage for the prior pictures. The foundation sill board has no structural value.

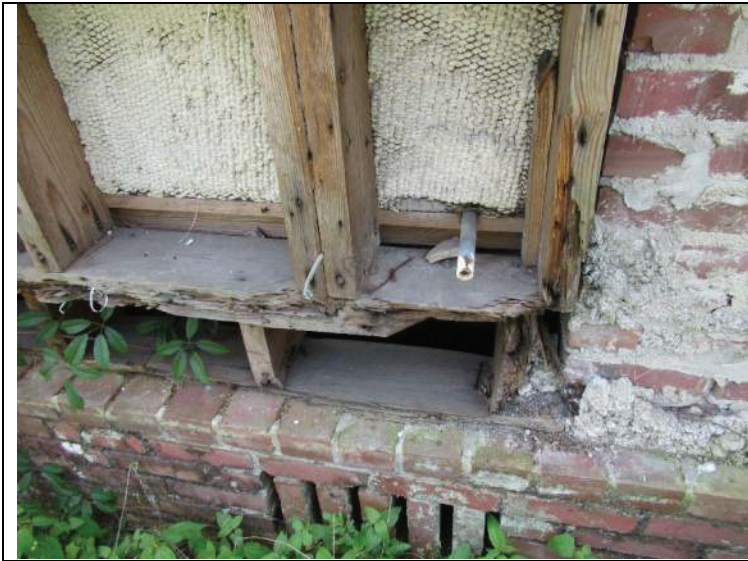
Photograph No. 17.

Closer view of damage by a chimney. The foundation sill board, floor joist bearing, and wall bottom plate have no structural value due to damage.

A risk of wall / floor structure collapse is feasible.

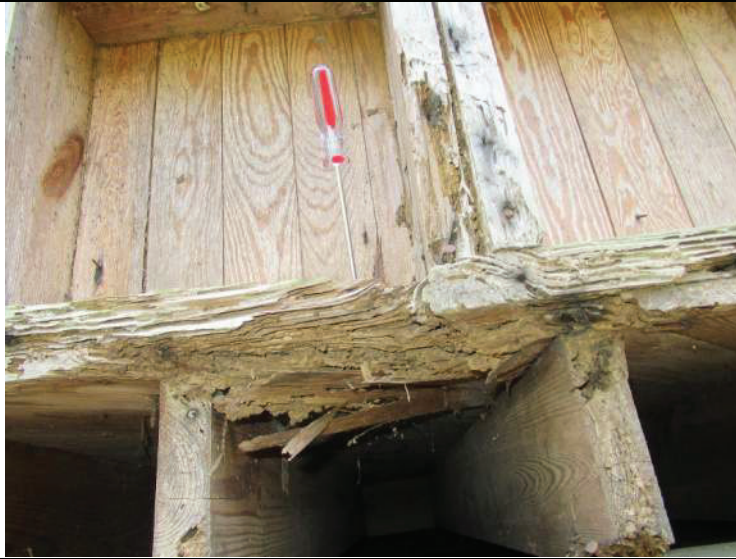
Photograph No. 19.

Closer view of damage for the prior picture.

A risk of wall / floor structure collapse is feasible.

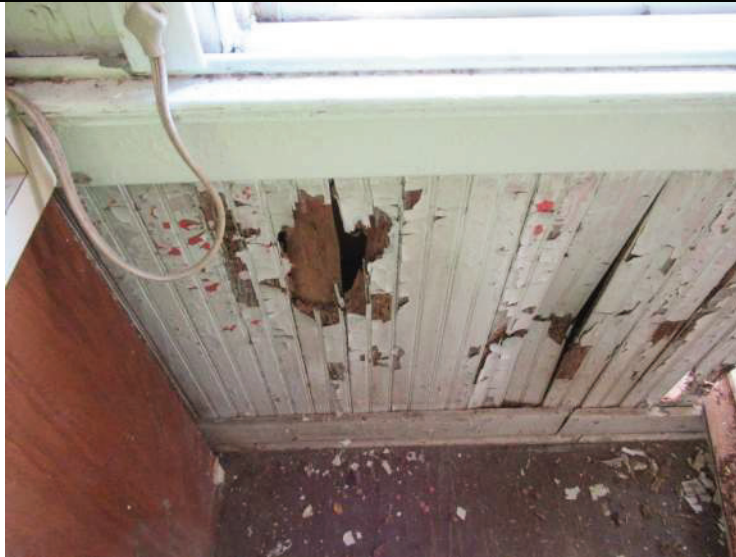
Photograph No. 21.

Interior view of south elevation exterior structural wall. Wall panel under window has no structural strength.

A risk of wall / floor structure collapse is feasible.

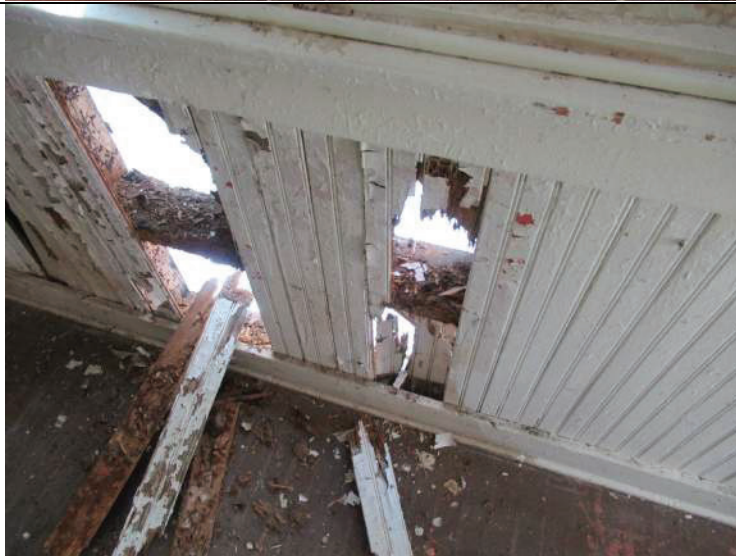
Photograph No. 22.

Interior view of south elevation exterior structural wall. Wall panel under window has no structural strength.

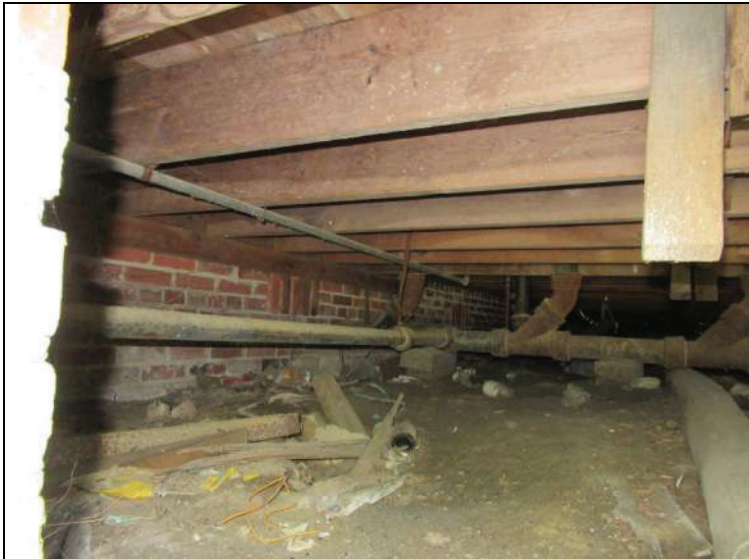
Photograph No. 23.

Interior side of perimeter foundation brick stem wall with 2x8 joist resting on.

Mid-span "X" cross bracing broken off bottom edge of floor joist.

A risk of wall / floor structure collapse is feasible.

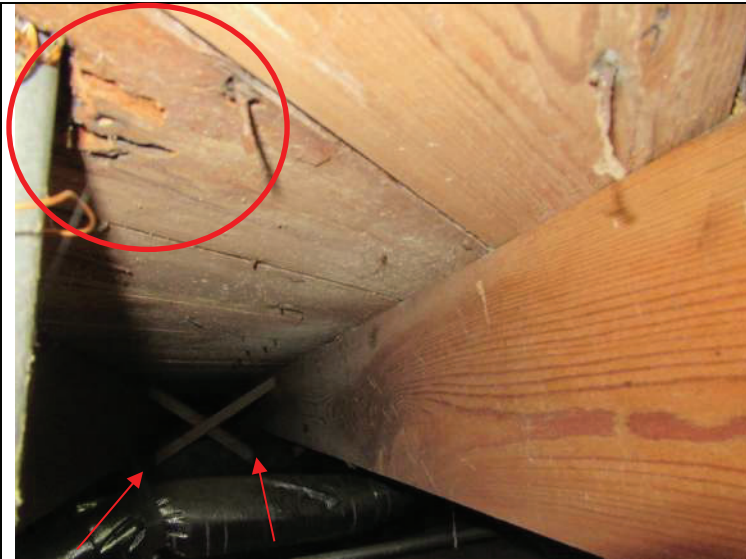
Photograph No. 25.

Floor sub-floor termite damage is shown in the oval.

Mid-span "X" cross bracing broken off bottom edge of floor joist.

A risk of wall / floor structure collapse is feasible.

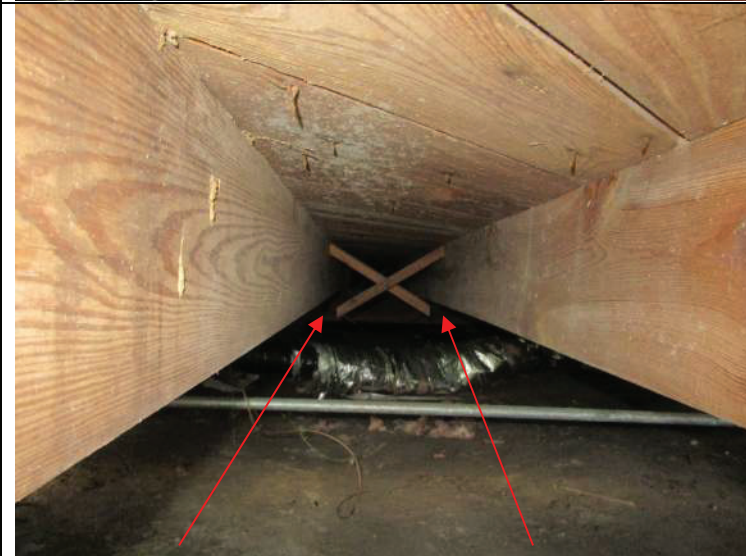
Photograph No. 26.

Mid-span "X" cross bracing broken off bottom edge of floor joist.

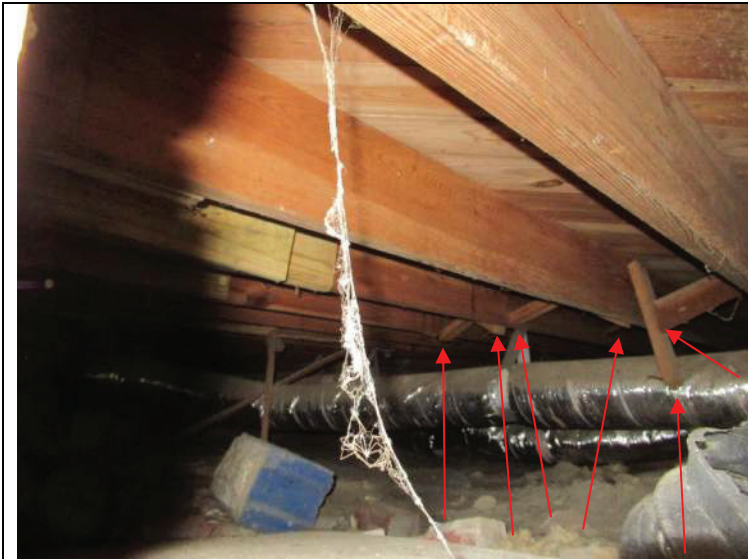
Photograph No. 27.

Mid-span "X" cross bracing broken off bottom edge of floor joist.

A risk of wall / floor structure collapse is feasible.

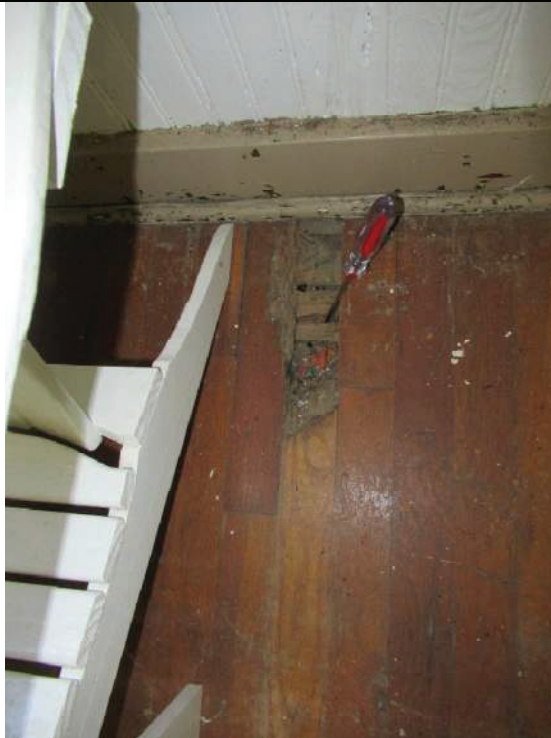
Photograph No. 28.

Damaged wood floor and sub-floor observed along exterior walls in several locations.

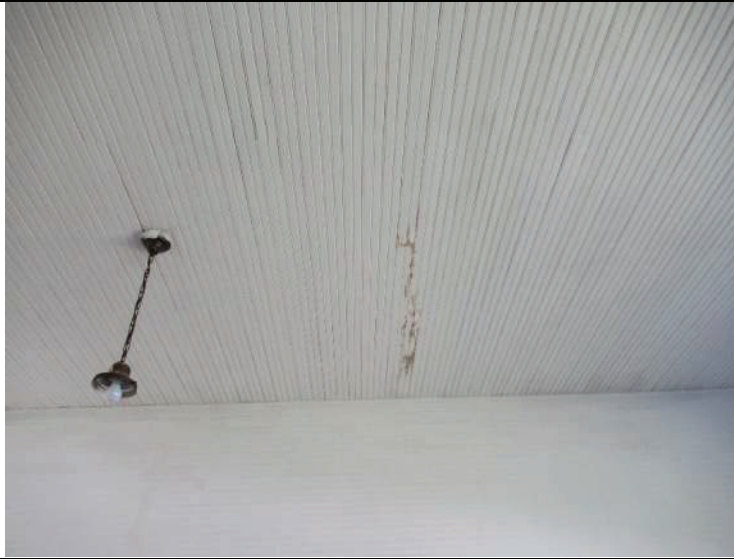
Photograph No. 29.

Damaged wood ceiling observed
in nearly every room.

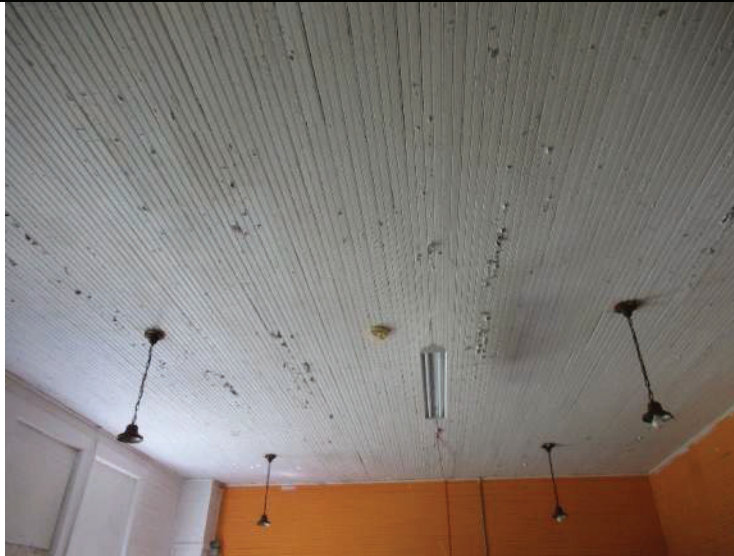
Photograph No. 30.

Damaged wood ceiling observed
in nearly every room.

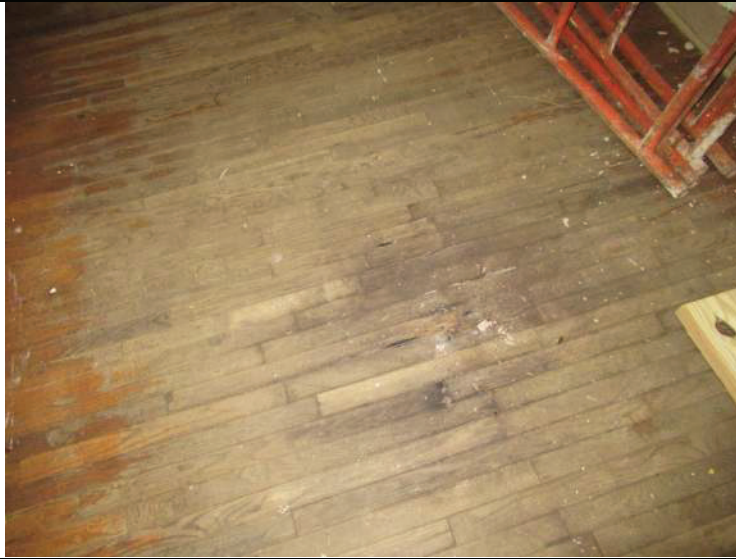
Photograph No. 31.

Typical damaged wood floor.
Both the flooring and sub-
flooring had damage. This was
throughout the building.

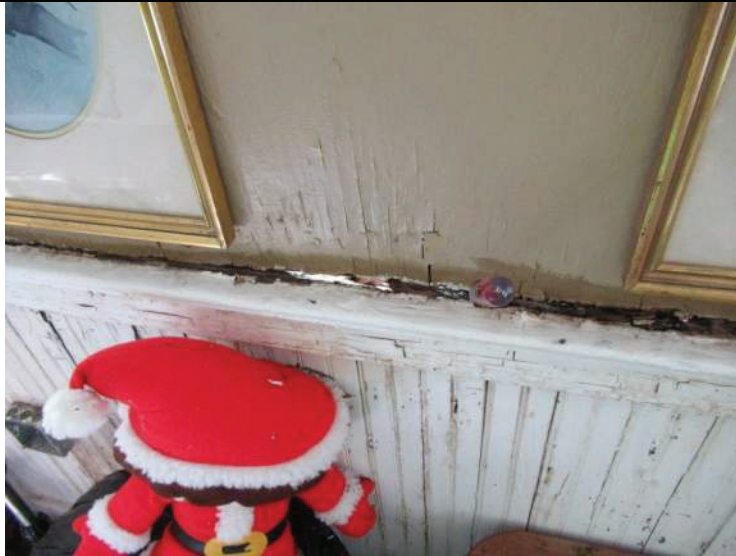
Photograph No. 32.

Typical damaged wood wall
interior surfaces.

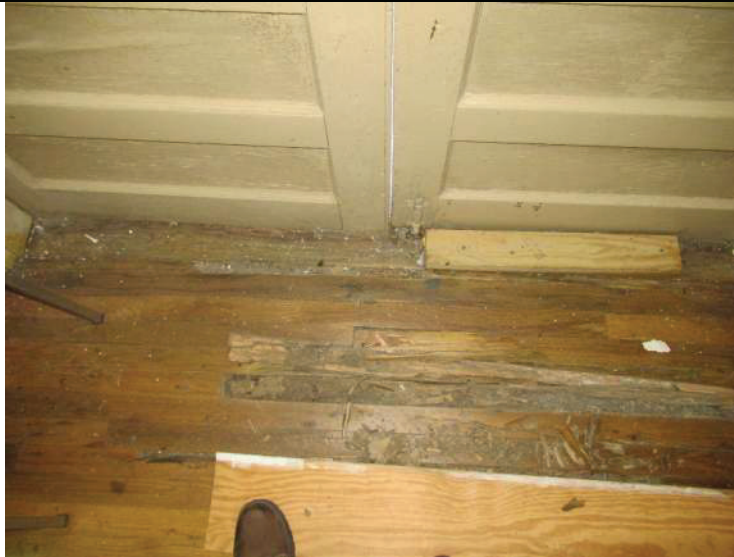
Photograph No. 33.

West entry door had significant floor damage and was found structurally unsound.

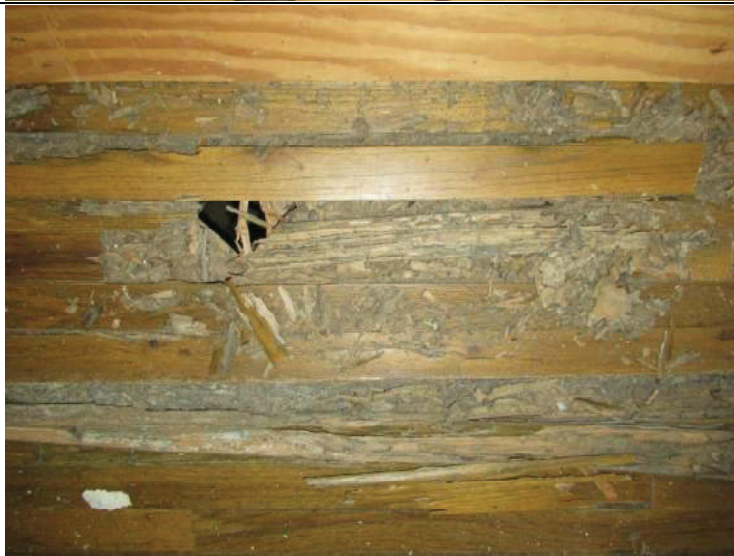
Photograph No. 34.

Temporary loose laid plywood removed from the above picture showing gaping hole in floor assembly.

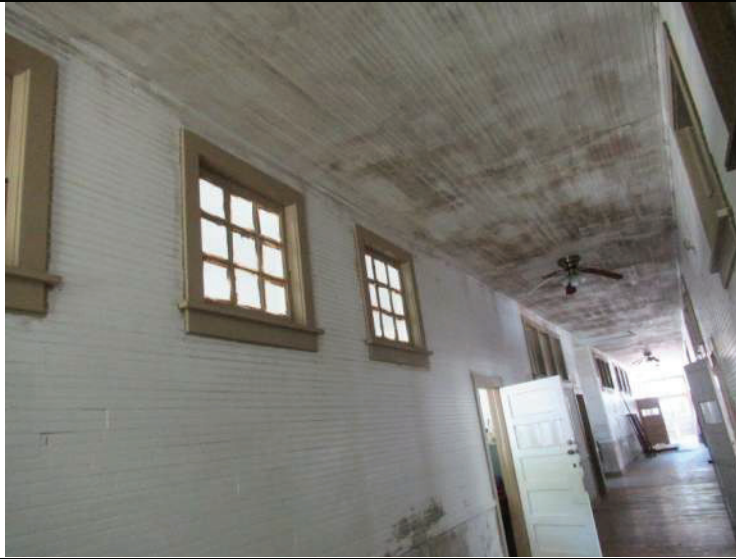
Photograph No. 35.

Significant interior damage with apparent organic growth on the surfaces.

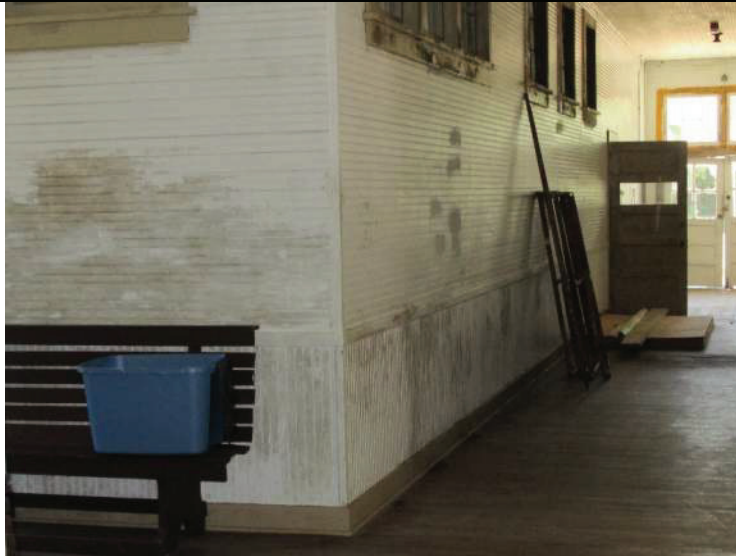
Photograph No. 36.

Significant interior damage with apparent organic growth on the surfaces.

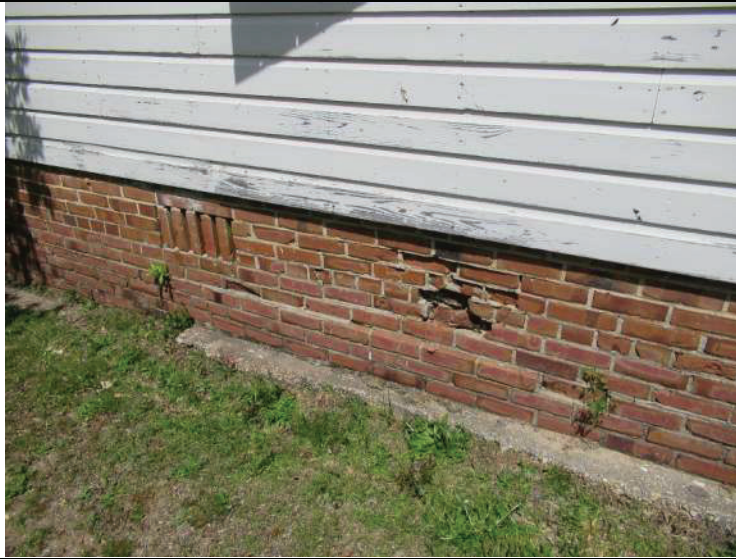
Photograph No. 37.

The stem foundation walls had several areas of damage from wear and tear or vehicles hitting it.

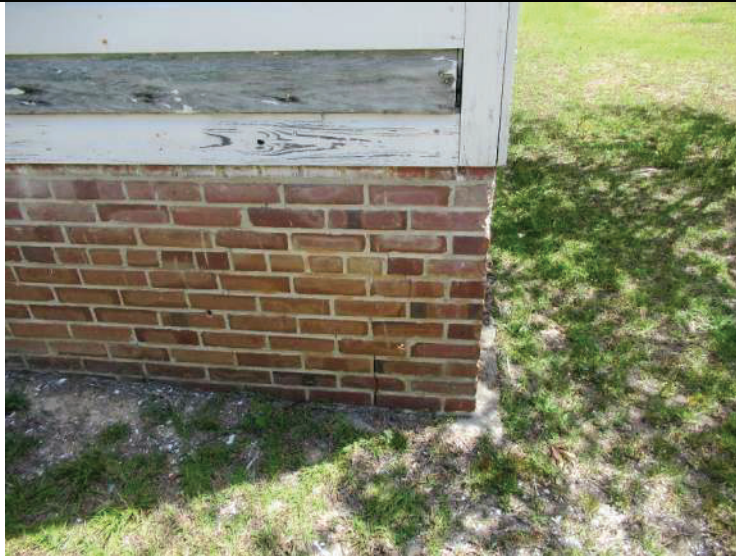
Photograph No. 38.

Brick work in stem foundation walls have numerous mortar cracks throughout the building.
